Technical Evaluation of the Gold King Mine Incident

San Juan County, Colorado

U.S. Department of the Interior
Bureau of Reclamation
Technical Service Center
Denver, Colorado

October 2015

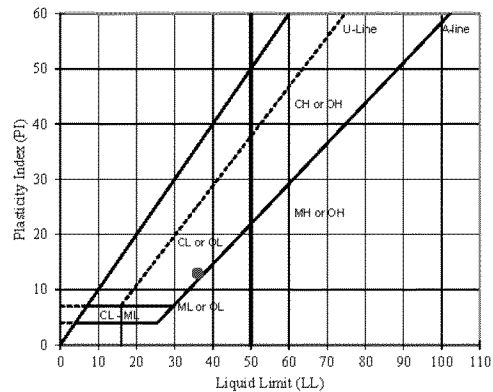
PROJECT NAME: USBR/Lab Testing - 2014/CO
SAMPLE ID: #2
TYPE: Pail

Sieve Analysis (Initial Separation on No. 4 Sieve)	Particle Size		Description	Percentage
	Sieve	(mm)		
	3-inch	75.0		100.0
	1.5-inch	37.5		95.6
	1-inch	25.0	Coarse Gravel	23.12
	3/4-inch	19.0		76.9
	3/8-inch	9.5		52.8
	#4	4.8	Fine Gravel	39.15
	#10	2.00	Coarse Sand	9.02
	#20	0.85	Medium Sand	9.84
	#40	0.43		18.9
	#60	0.25	Fine Sand	6.63
	#100	0.15		14.5
	#200	0.075	Silt or Clay Fines	12.24

Visual Description:
Clayey gravel with sand, yellowish brown, moist

LL	PL	PI
36	23	13
